Infrared Inspection Samples

Thermography Inspection at (Site)	Date: (date)
---	--	-------------------------

Summary of Inspection

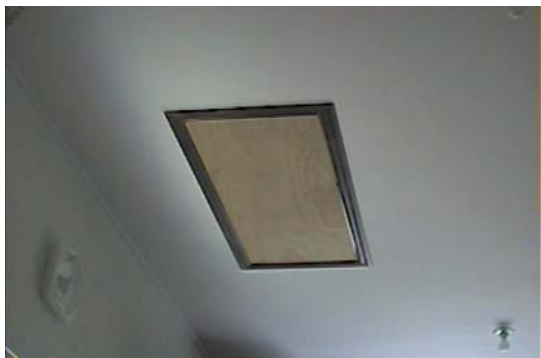
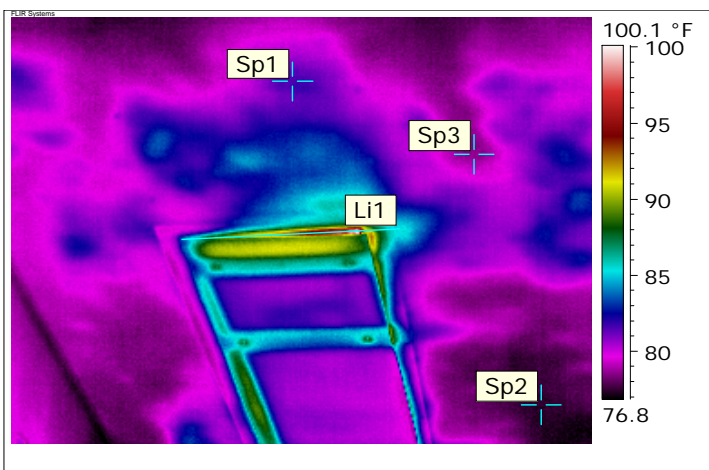
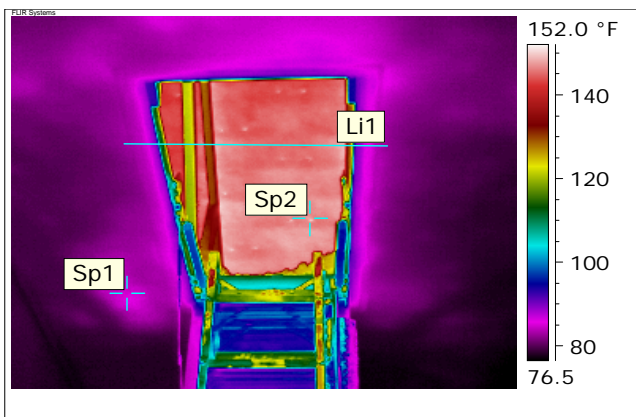
This series of pictures shows the door leading to the attic closed and open. While it's closed heat is still leaking into the room. The door should be checked to make sure it is flush with the frame and/or more insulation should be added.

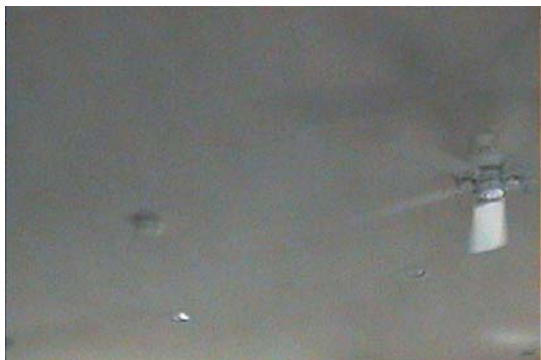
This picture shows a section of the ceiling drywall that was repaired but the insulation was not replaced in the attic.. Insulation should be replaced above the repaired section.

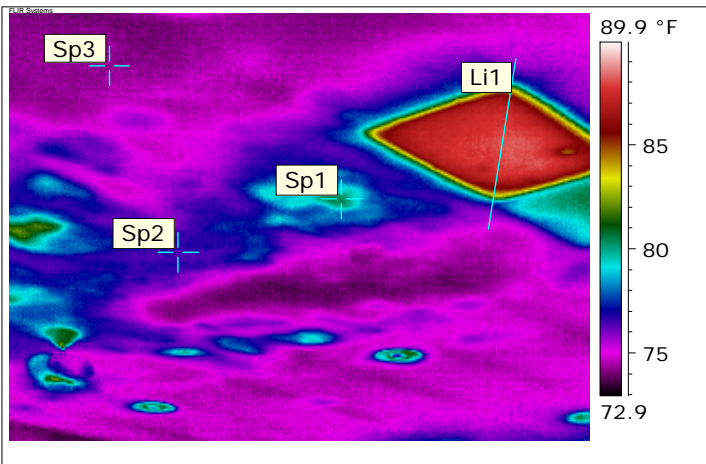
Another view of the a repaired ceiling where insulation was not replaced in the attic. Insulation should be replaced in the attic.

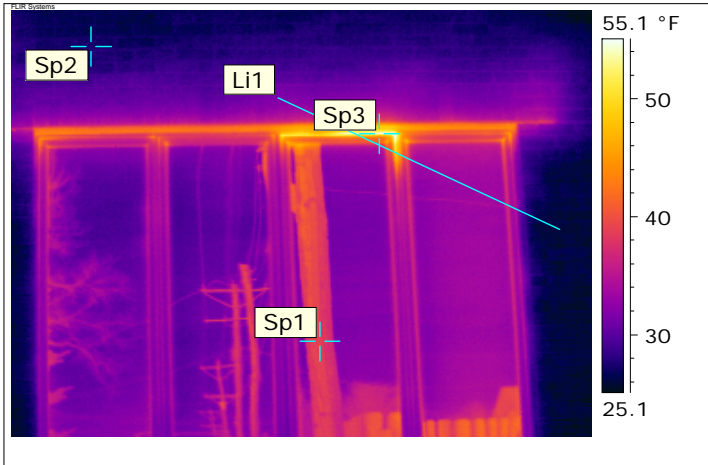
This picture shows a window at a commercial building. Window seals should be inspected and replaced to prevent energy loss and or water from seeping in through the gap.

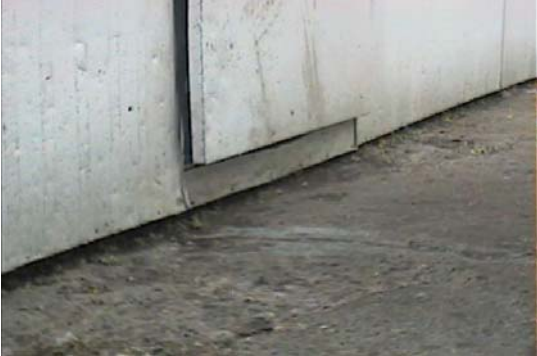
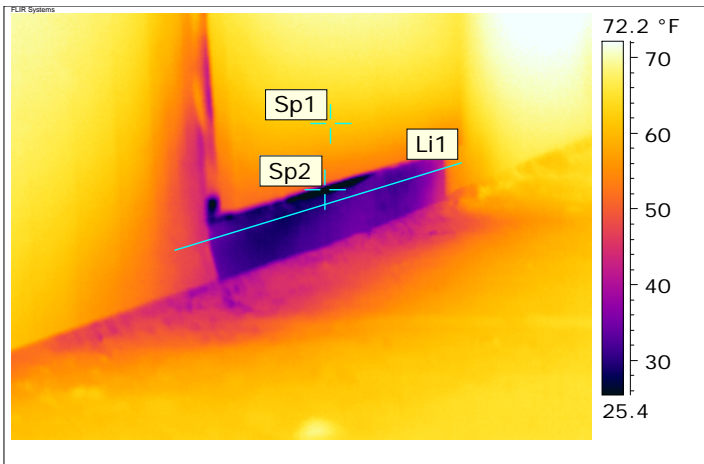
This picture shows the door to an outdoor walk in freezer. The door seals should be inspected and replaced to prevent energy loss.

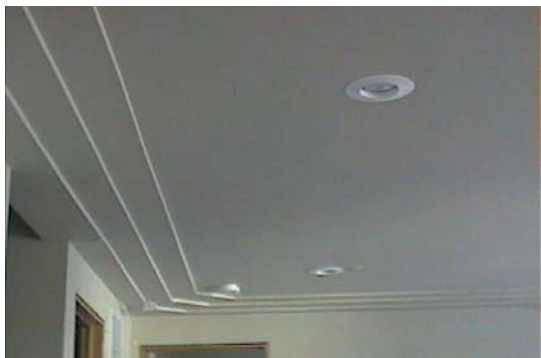
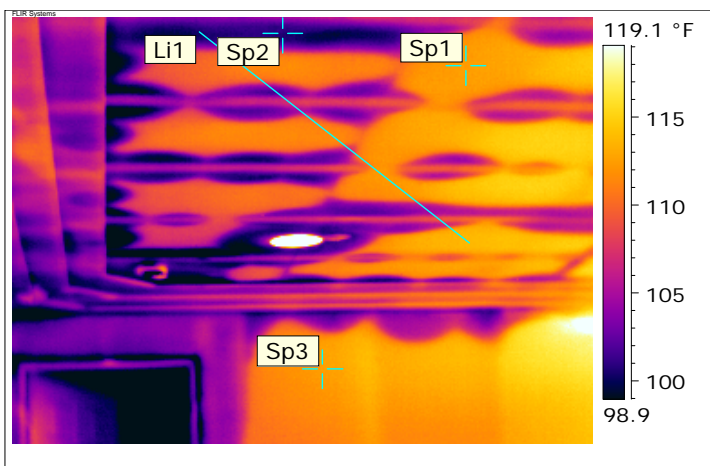
This picture shows the basement ceiling of a residential home. The dark spots is moisture from water pipes that broke in the main floor ceiling. The house was dried with minimal drywall tear out utilizing the Dry-Vex High Heat Unit. **NOTE: Infrared Maximum temperature is due the recessed light being on.**

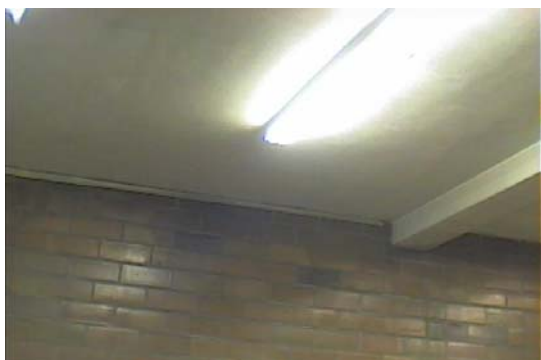
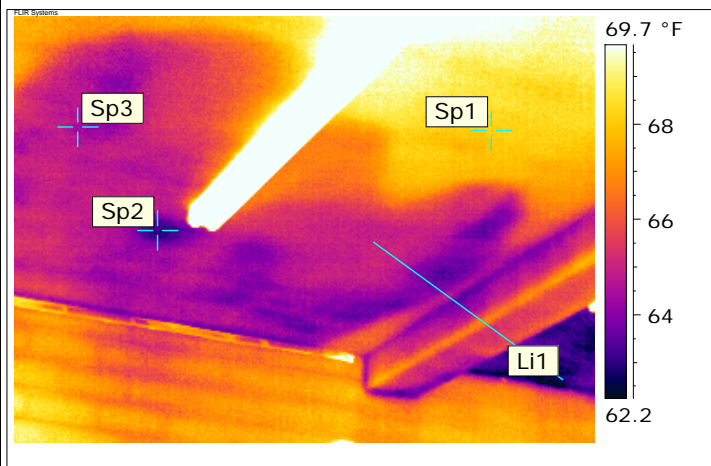
This picture shows a plaster ceiling in a commercial building. Darker areas are moisture. This ceiling and the rest of the building was dried with no tear out of walls, ceilings or carpet utilizing the Dry-Vex High Heat Unit. This picture was taken on January 22nd 2008, one day before the next picture.

NOTE: The Infrared Maximum temperature is due to the fluorescent light fixture in the picture.

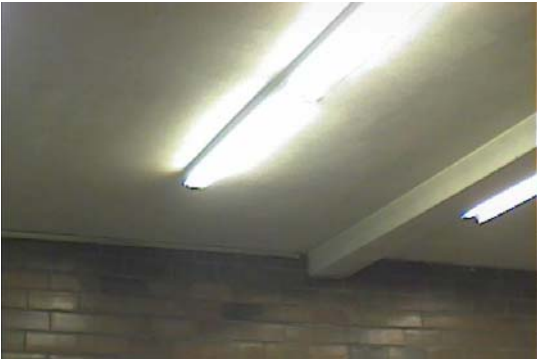
This picture shows a plaster ceiling in a commercial building. Darker areas are moisture. This ceiling and the rest of the building were dried with no tear out of walls, ceilings or carpets utilizing the Dri-Vex High Heat Unit. This picture was taken on January 23rd 2008 one day after the previous picture.

NOTE: The Infrared Maximum temperature is due to the fluorescent light fixture in the picture.

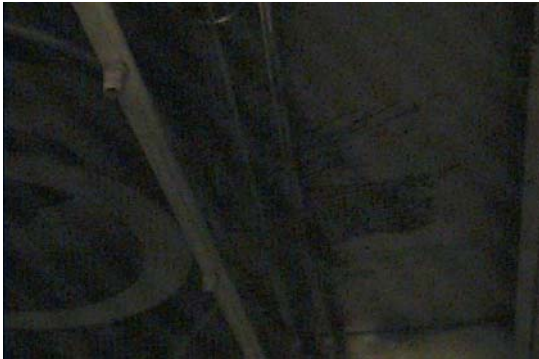
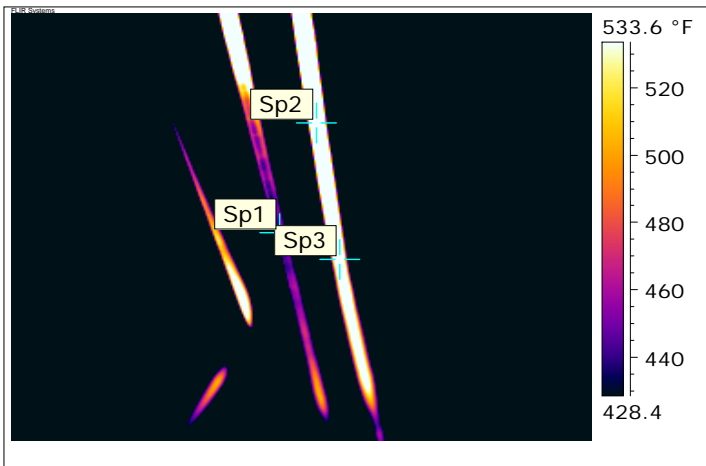
This picture shows the inside of a walk in smoke house. The conductive heating element is on and the darker areas indicate a much lower temperature than the brighter areas. The heating element should be inspected and repaired or replaced.

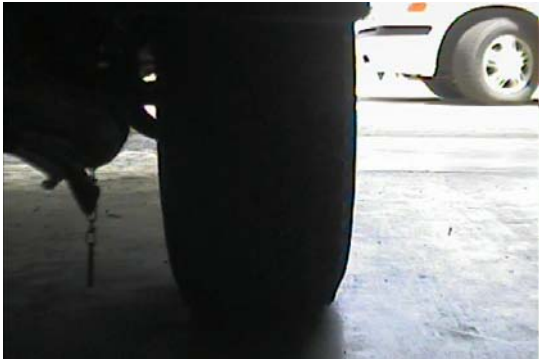
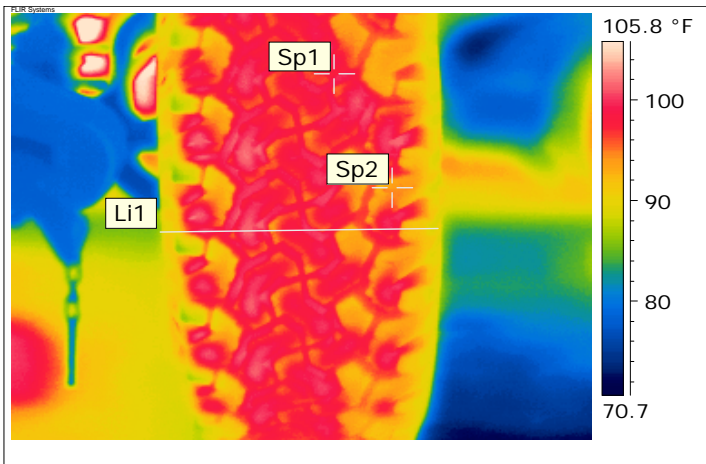
This picture shows the driver's side tire on a Jeep. Compare with passenger side tire below. This type of inspection can be used as a part of a preventative maintenance program.

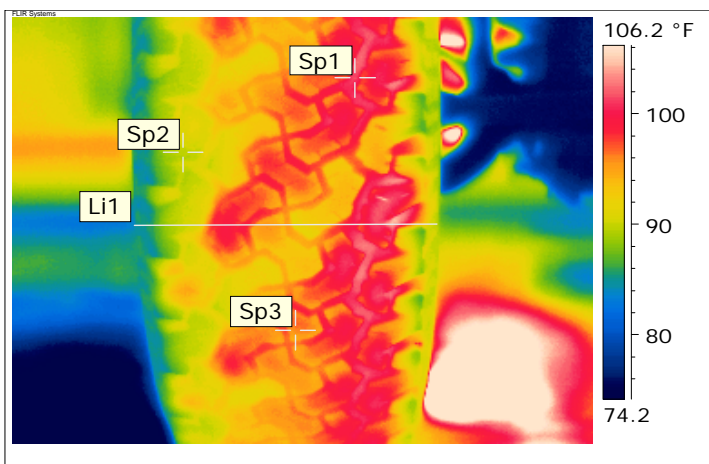
This picture shows the passenger side tire on a Jeep. The unusual heat patterns indicate unusual wear which could be due to improper inflation or tire imbalance. This type of inspection can be used as a part of a preventative maintenance program.
